**Flood Control Project Maintenance
Levee Inspections**

Maintenance Issue Types Only, Levee Inspection Report By Mile - Spring 2018

Sutter Maintenance Yard Nelson Bend

Waterway	Bank	Unit Miles	Inspection Start/End	Inspector
Unit No. 01 Feather River West Levee - Nelson Bend		0.50	04/04/2018 04/04/2018	Sterling York

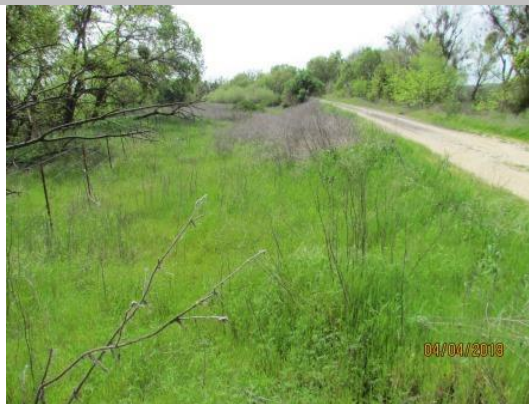
Photo 1 of 1 : SP_2018_ST0006_471_15_20180409_00012.jpg

LM Start	0.02	Rating **	U	Issue No.	15
LM End	0.42	Issue Type +	Ma	Location *	WS
Category	Earthen Levee			GPS Latitude/Longitude	
				Start	End
Item	Vegetation			38.886883 °	38.881287 °
				-121.614797 °	-121.614490 °
DWR ID	DWR_ST0006_01_f_2015_15				
Comment Code					
V2 : Remove the wild growth other than native grasses from the levee slopes.					
Inspector Comment					
Remove the annual vegetation and wild growth. Spring 2018.

View of the vegetation along the waterside slope looking downstream, Spring 2018.

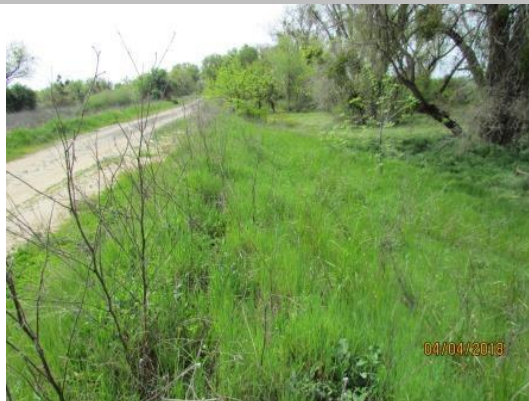
Photo 1 of 1 : SP_2018_ST0006_471_2_20180409_00013.jpg

LM Start	0.02	Rating **	U	Issue No.	2
LM End	0.46	Issue Type +	Ma	Location *	LS
Category	Earthen Levee			GPS Latitude/Longitude	
				Start	End
Item	Vegetation			38.886883 °	38.880833 °
				-121.614797 °	-121.614387 °
DWR ID	DWR_ST0006_01_f_2015_2				
Comment Code					
V2 : Remove the wild growth other than native grasses from the levee slopes.					
Inspector Comment					
Remove the annual vegetation and wild growth. Spring 2018.

View of the vegetation along the landside slope looking downstream, Spring 2018.

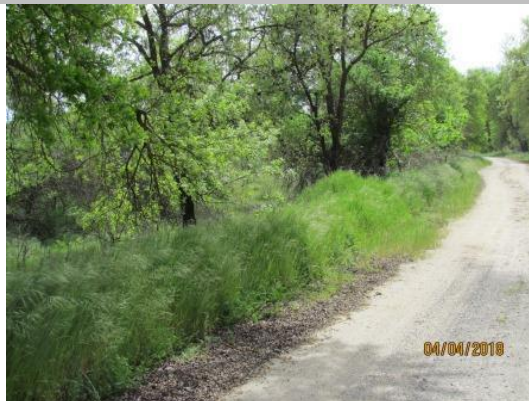
Photo 1 of 1 : SP_2018_ST0006_471_1_20180409_00015.jpg

LM Start	0.13	Rating **	U	Issue No.	1
LM End	0.50	Issue Type +	Ma	Location *	WS
Category	Earthen Levee			GPS Latitude/Longitude	
				Start	End
Item	Trim / Thin Trees			38.885396 °	38.880295 °
				-121.615595 °	-121.614147 °
DWR ID	DWR_ST0006_01_f_2017_1				
Comment Code					
T3 : Trim and thin trees to allow visibility of the ground and room to flood fight.					
Inspector Comment					
Trim up the trees 5 feet for access and visibility, Spring 2018.

View looking downstream waterside of the over growth of trees, Spring 2018.

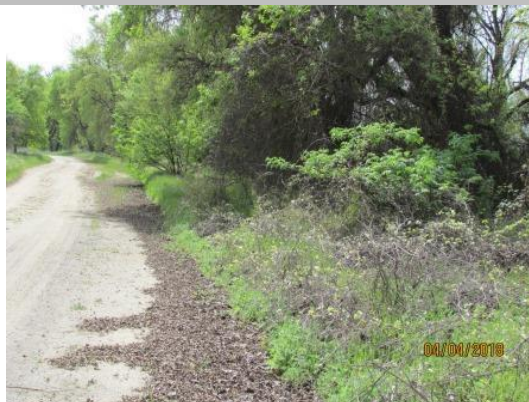
Photo 1 of 1 : SP_2018_ST0006_471_3_20180409_00017.jpg

LM Start	0.13	Rating **	U	Issue No.	3
LM End	0.50	Issue Type +	Ma	Location *	LS
Category	Earthen Levee			GPS Latitude/Longitude	
				Start	End
Item	Trim / Thin Trees			38.885396 °	38.880295 °
				-121.615595 °	-121.614147 °
DWR ID	DWR_ST0006_01_f_2017_3				
Comment Code					
T3 : Trim and thin trees to allow visibility of the ground and room to flood fight.					
Inspector Comment					
Trim up the trees 5 feet for access and visibility, Spring 2018.

View looking downstream landside of the over growth of trees, Spring 2018.
